Full Reserve Study

Village at Lake Chelan

Manson, WA

Report #1011

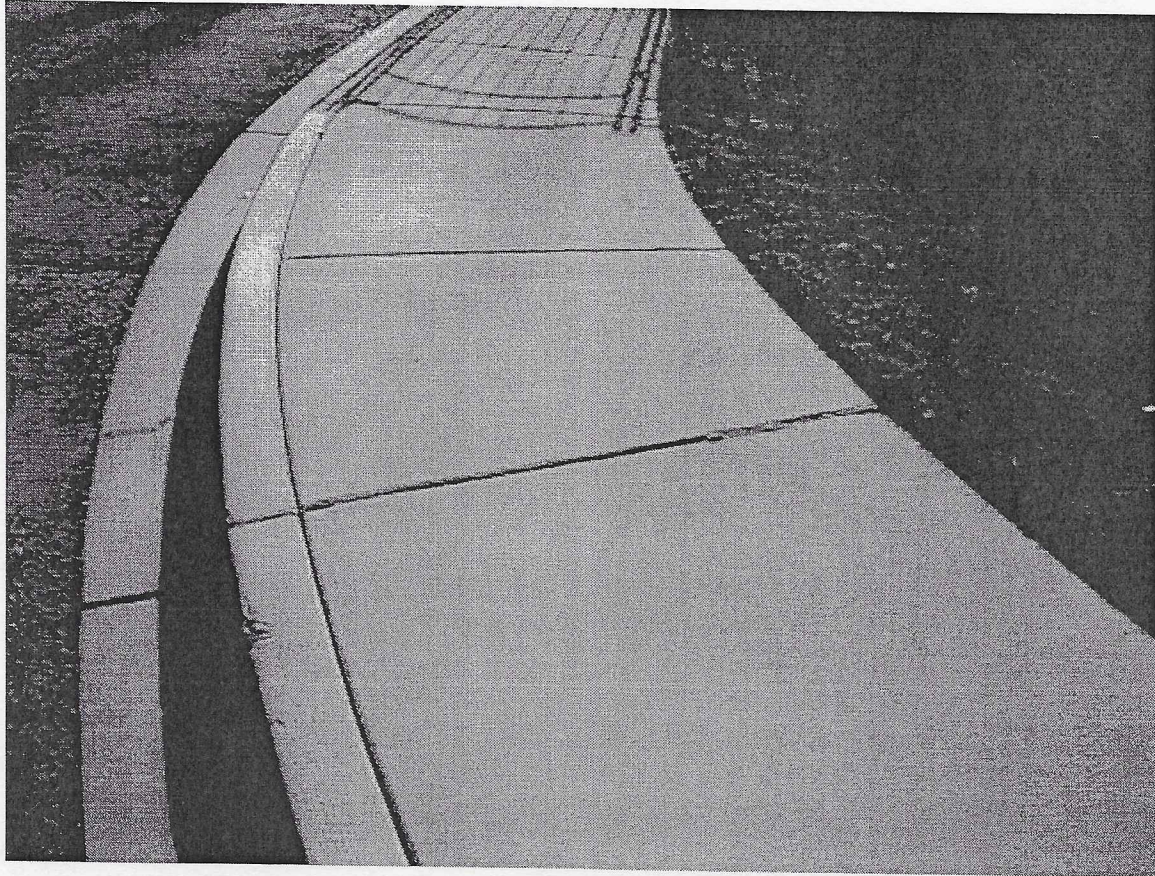
Component: Concrete – Repair/Replace

Comments: Fair condition with no damage or unexpected deterioration observed. We suggest regularly inspections of concrete, with repair as needed to prevent water penetration and damage. Periodically pressure wash for appearance and repair any trip hazards immediately to ensure safety. We do not expect large-scale or total replacement within the scope of this study. No reserve funding suggested.

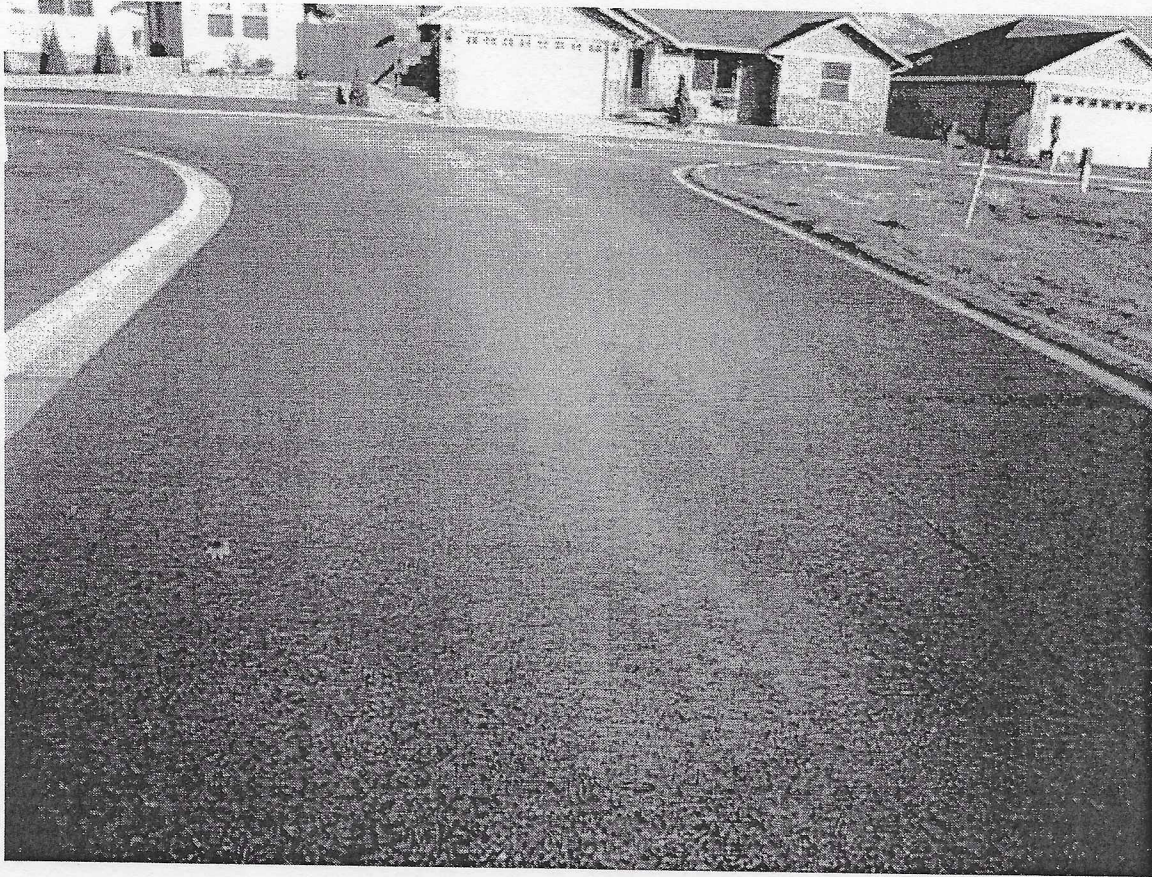
Component: Asphalt – Seal/Repair

Comments: Fair Condition with general wear and deterioration observed. Seal coating protects the asphalt from the weather elements and provides a uniform appearance. Incorporate any striping and curb repair into this project. Plan for regular seal coat cycles at the interval below.

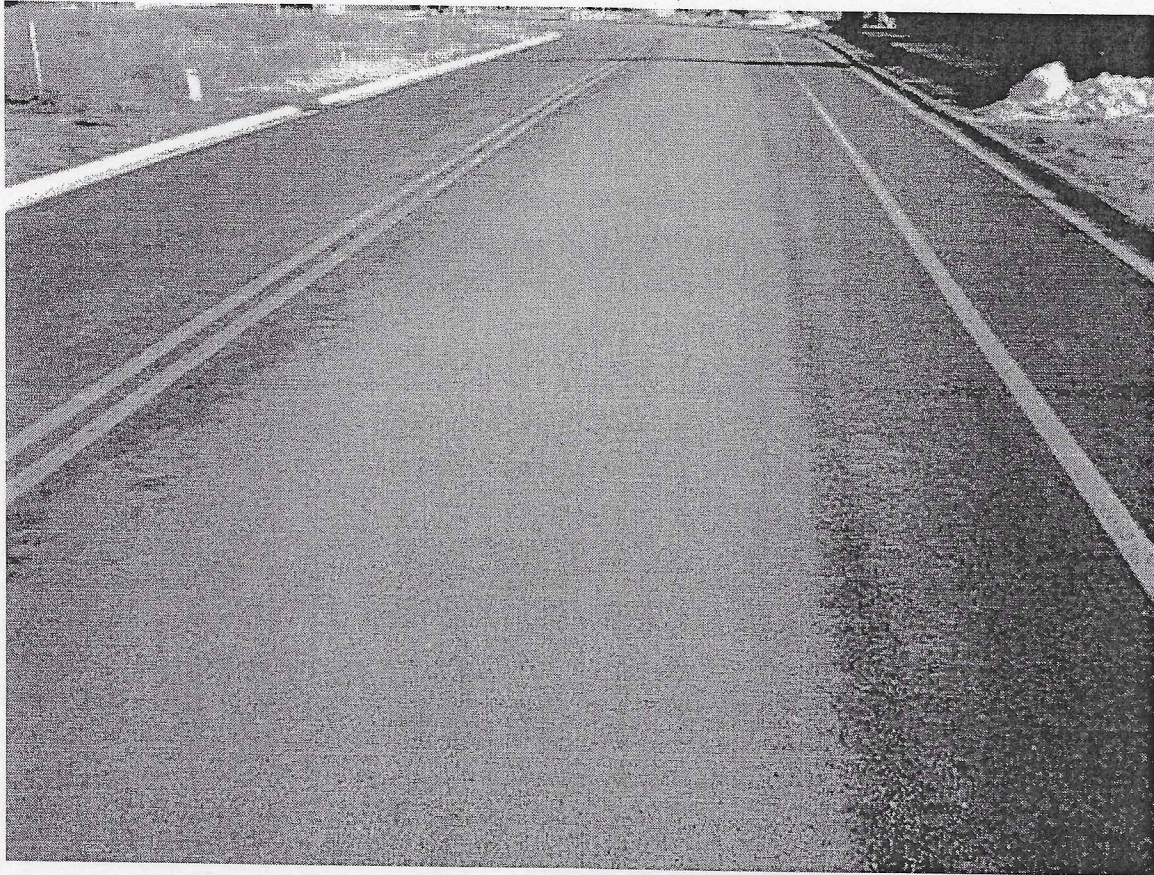
Component: Asphalt – Resurface

Comments: Fair condition with no cracking or settling observed. We suggest a seal coat every five years to obtain maximum life of asphalt surface. Repair cracks, clean oil stains promptly and ensure that drains are clear. Best to plan to overlay asphalt at roughly the time frame below.

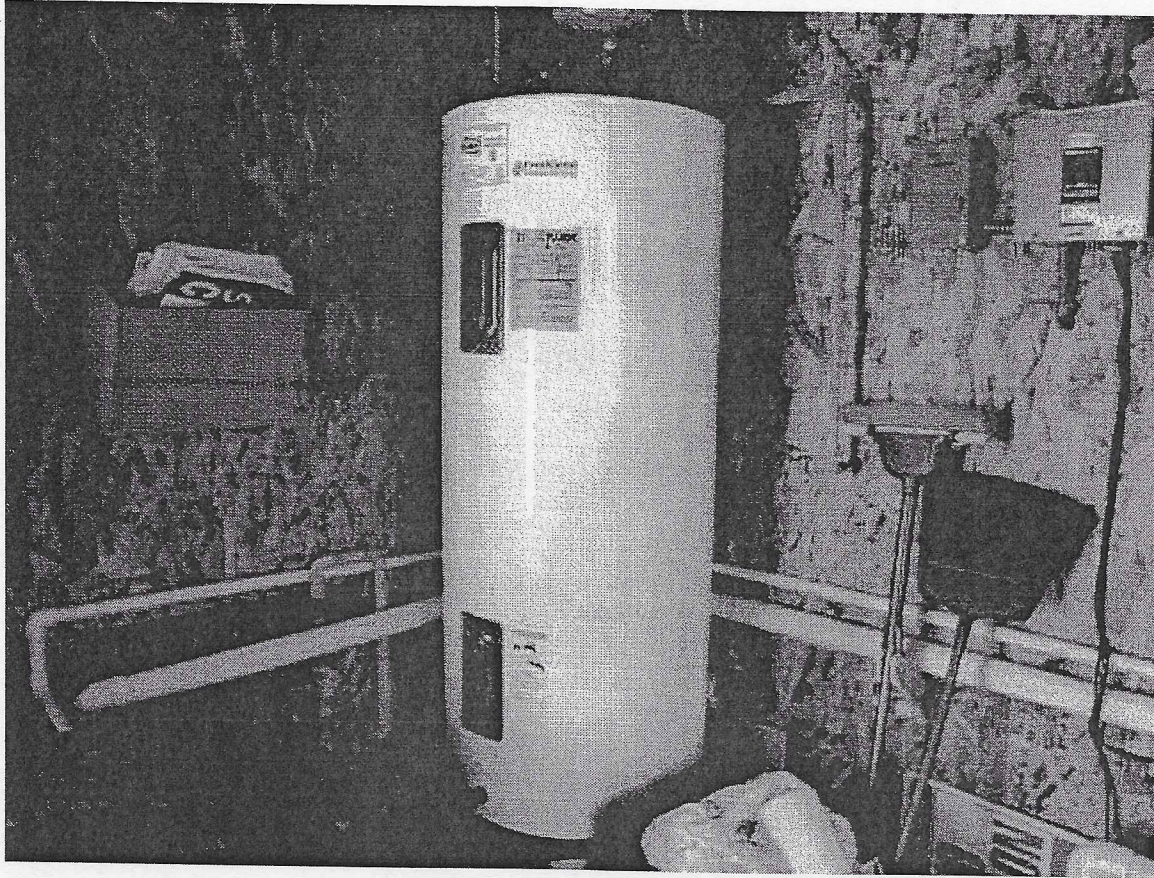
Component: Water Heater – Replace

Comments: No reported or observed problems. We assume the water heater to be in operating order. Have a professional inspect, maintain and repair as needed. Too small an expense to merit reserve funding, replace as needed from operating budget.

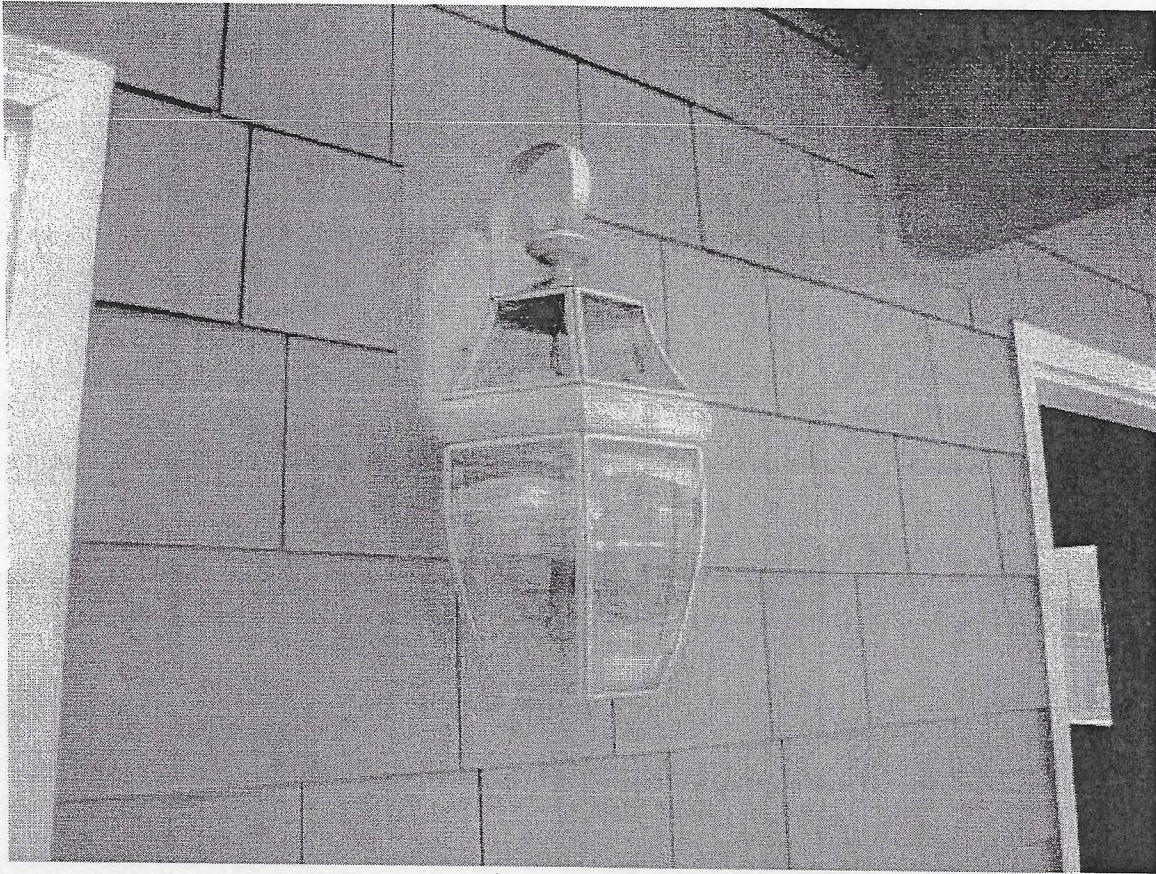
Component: Exterior Lights – Replace

Comments: Fair condition of assorted exterior lights. They are assumed to be in functional operating condition. Regularly inspect and change bulbs as needed. We do not expect large-scale replacement within the scope of this study. Replace as needed from general operating funds. No reserve funding suggested.

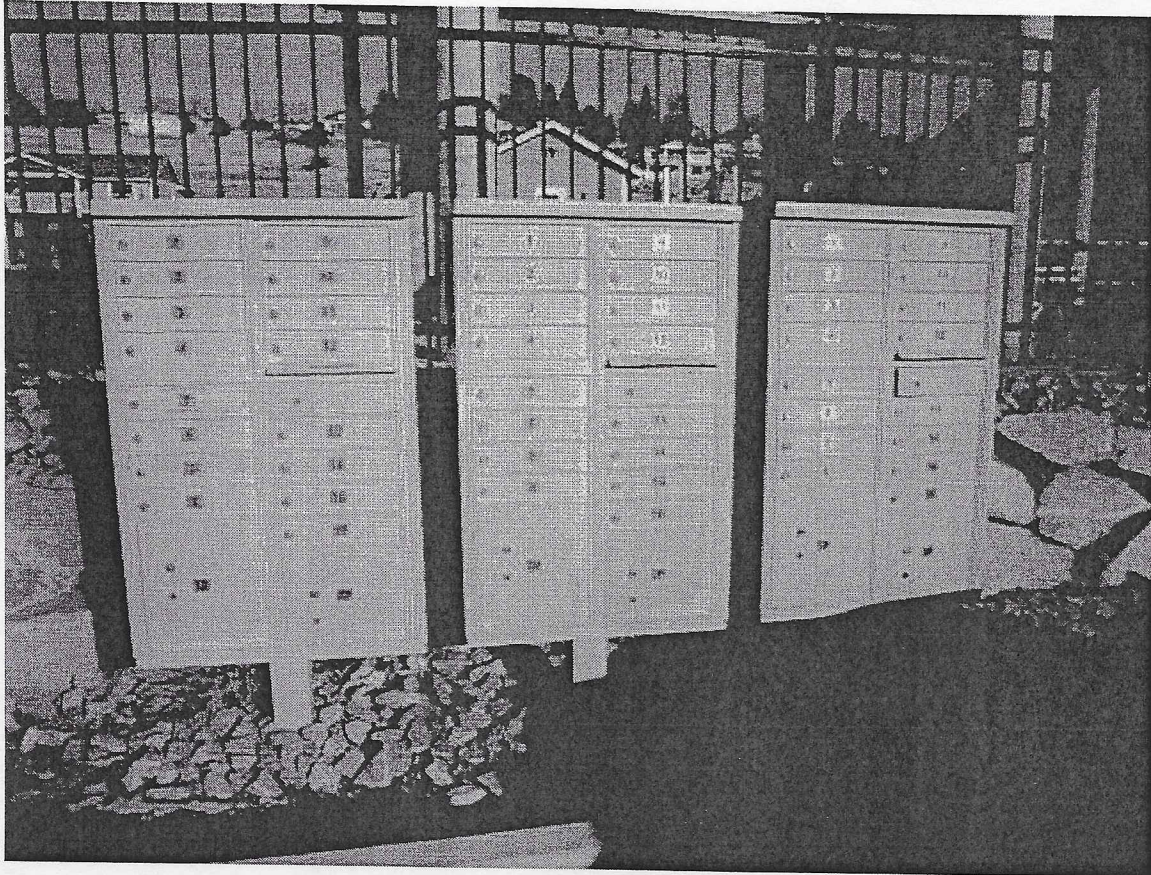
Component: Mailbox Clusters – Replace

Comments: Fair condition observed. Inspect regularly, clean and repair as needed from general maintenance budget. Best to plan for total replacement at roughly the time frame below due to constant usage and wear over time.
