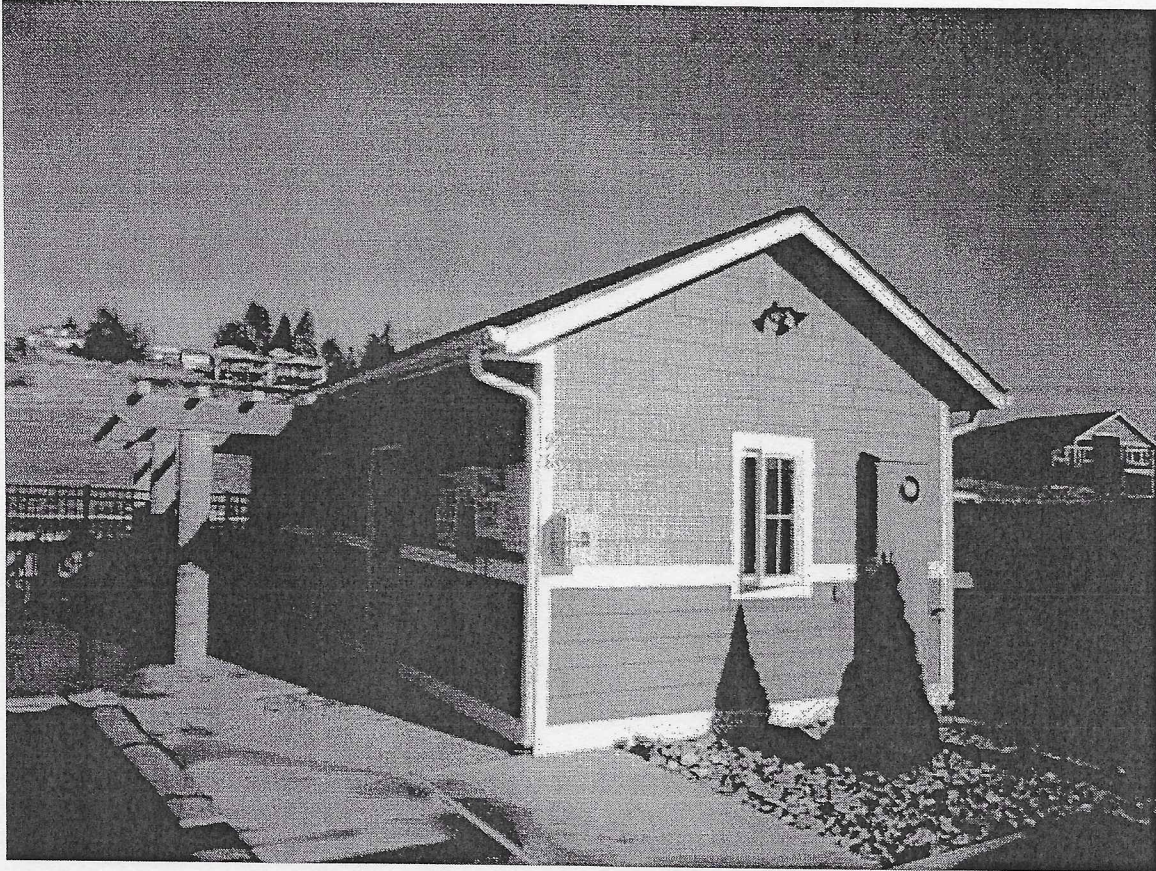
Component: Siding - Replace

Comments: Fair condition of fiber-cement observed during our limited scope visual inspection. We assume the siding was installed properly with adequate moisture barrier and waterproofing details. We recommend periodic evaluations of all siding with prompt repair as needed to ensure building waterproofing. Fiber cement siding is a durable product with ordinary care and maintenance. We do not expect large-scale or total replacement needs within the scope of this study. No reserve funding suggested.

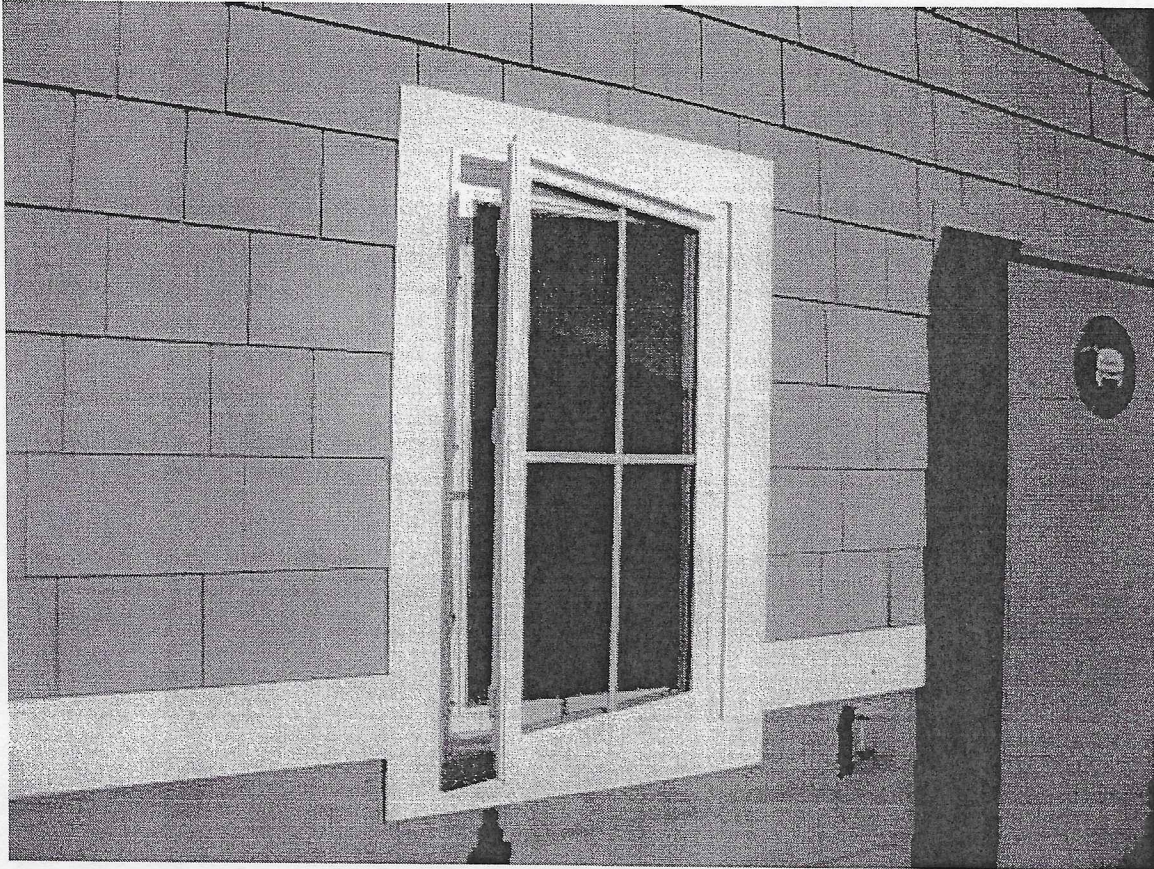
Component: Windows – Replace

Comments: No problems noted or reported during our visual scope inspection. We assume the windows to have been installed properly with adequate waterproofing details. We recommend periodic evaluations with prompt repair as needed to ensure building waterproofing and help prevent structural damage. Small amount of windows, we suggest replacement from the general maintenance funds. No reserve funding required.

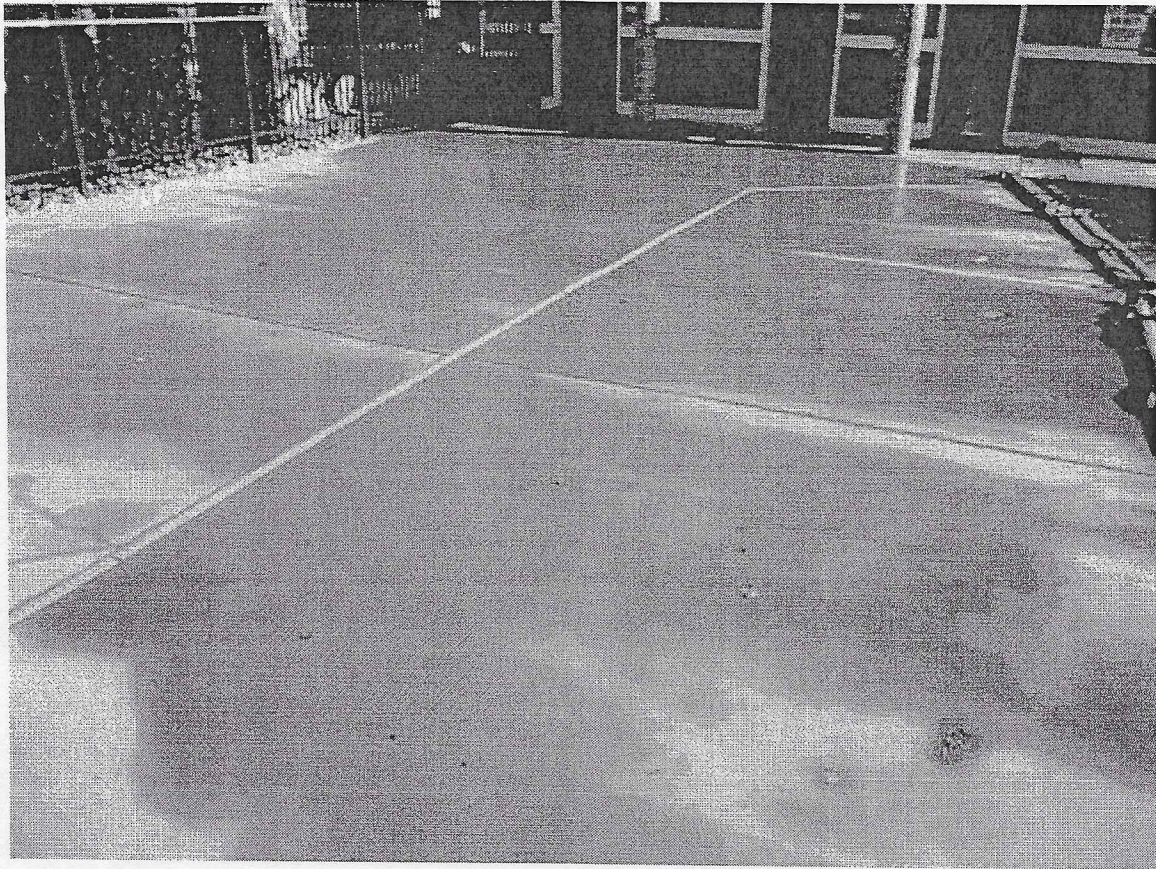
Component: Pool Deck – Resurface

Comments: Fair condition with no significant cracking evident at this time. Pressure wash regularly for appearance and fill any cracks that may develop to minimize further damage. Best to plan for total resurfacing at interval indicated below.

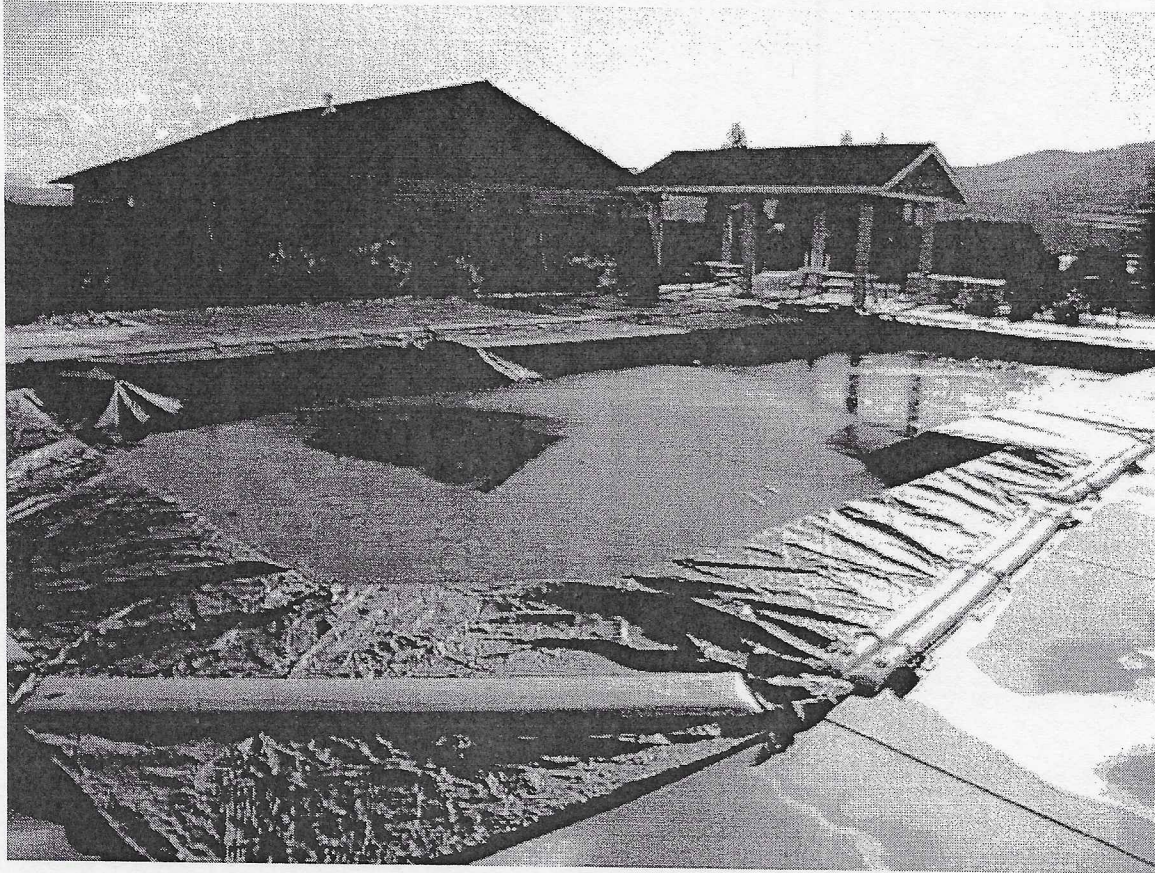
Component: Pool – Resurface

Comments: Fair condition of surface reported. Professional cleaning and maintenance are recommended to maximize life of this component. Best to plan for regular intervals of pool/spa resurfacing to maintain functionality and a quality appearance.

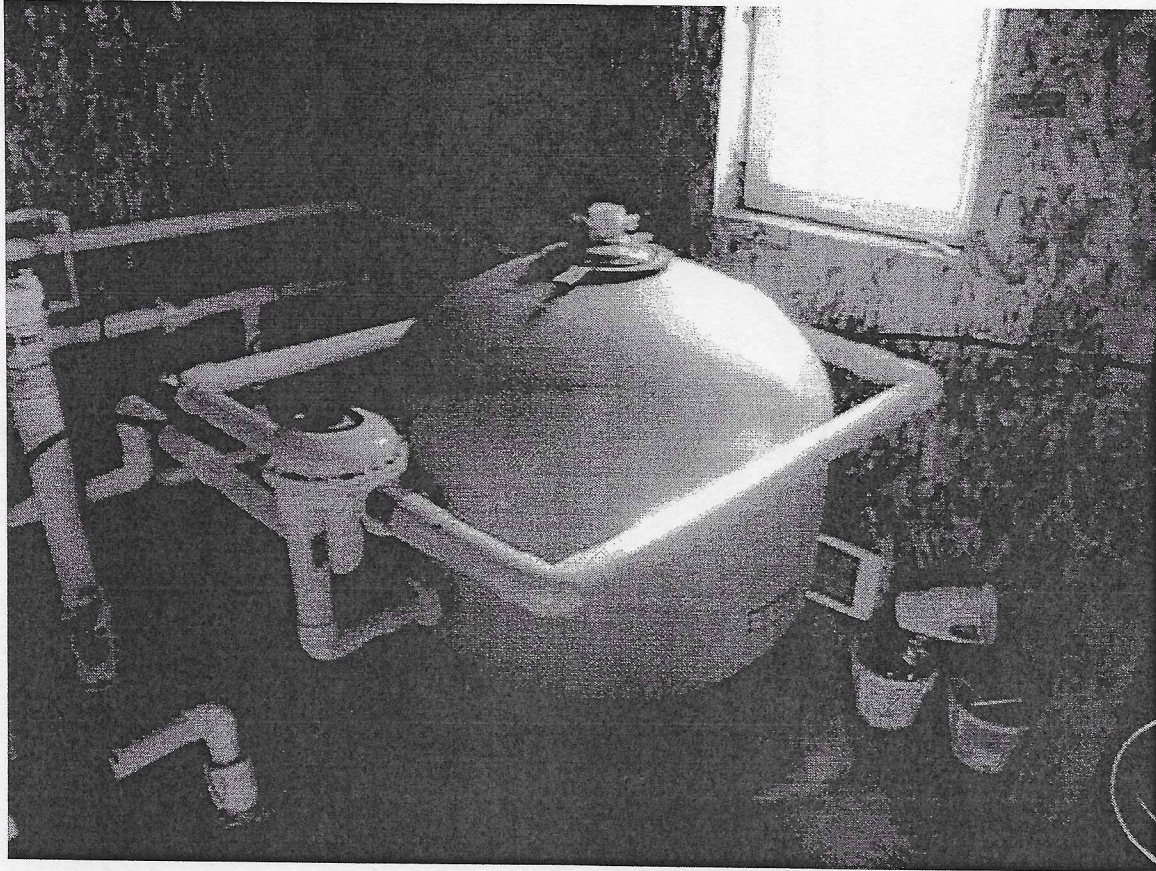
Component: Pool Filter – Replace

Comments: Fair and functional condition of filter. Clean regularly and maintain as needed. Replacement cycles of filters are difficult to predict and they are at a relatively low cost. Replacement is best suited as general maintenance expense, not as reserve component. No reserve funding suggested.

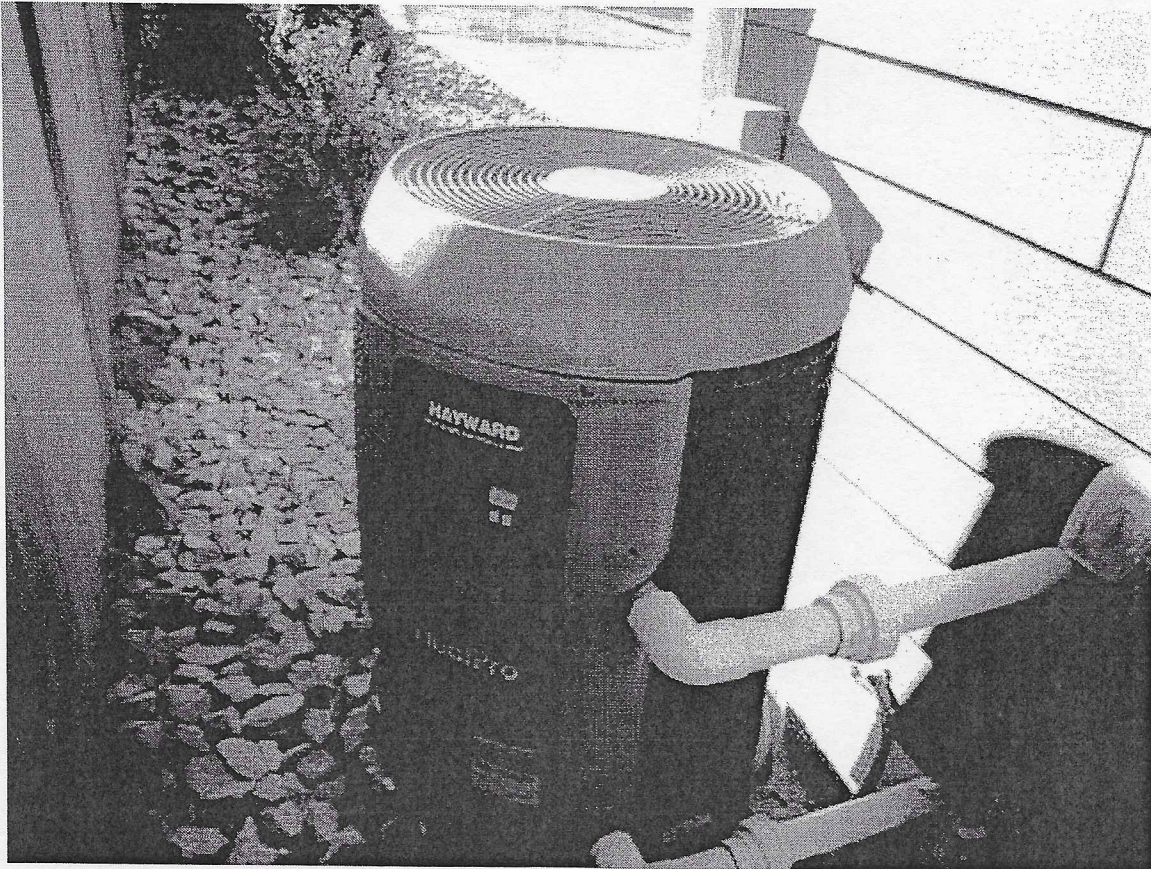
Component: Pool Heater – Replace

Comments: No reported or observed problems at this time. We recommend regular professional maintenance and repair to help maximize life cycles. Replacement cycles of these heaters are difficult to predict and they are best suited as general maintenance expense, not as reserve component. No reserve funding suggested.

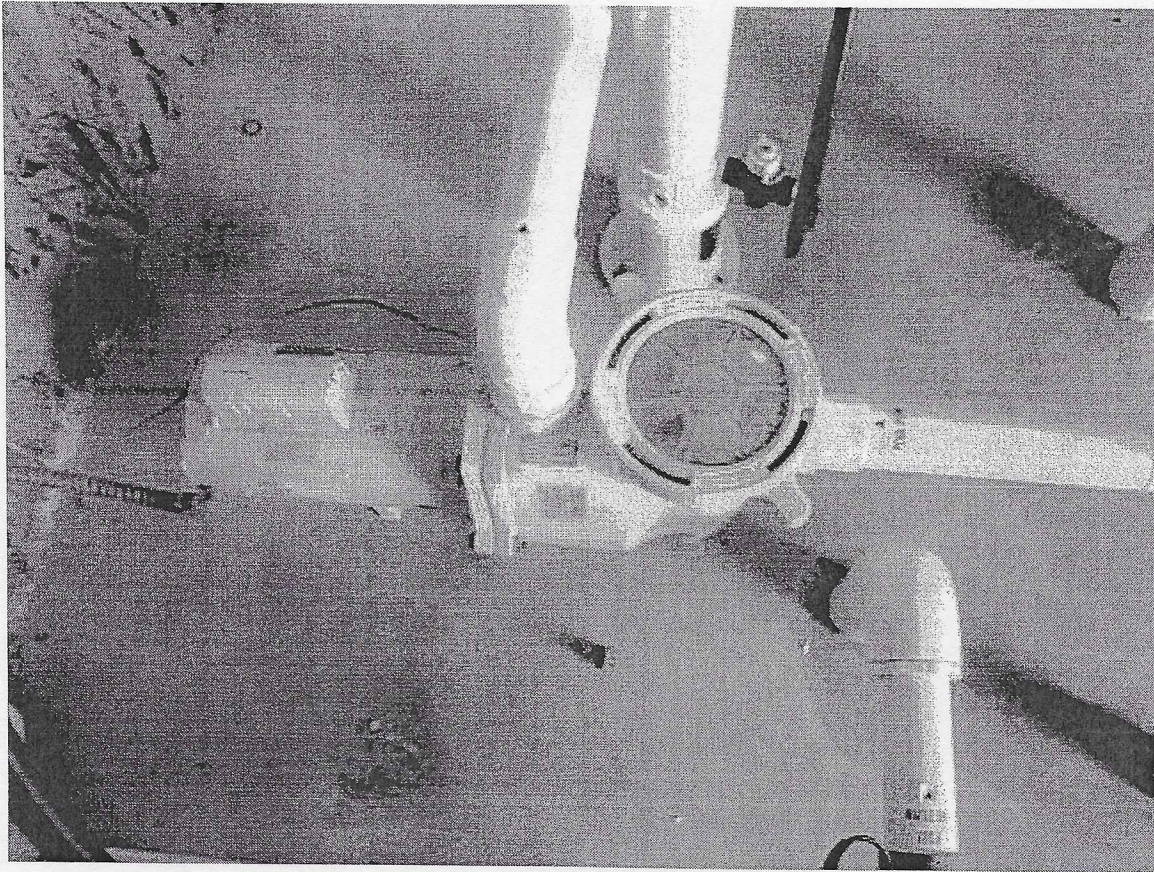
Component: Pool Pumps – Replace

Comments: Assumed to be in functional condition and operating as designed. Replacement cycles of pumps are difficult to predict and they are at a relatively low cost. Replacement is best suited as general maintenance expense, not as reserve component. No reserve funding suggested.

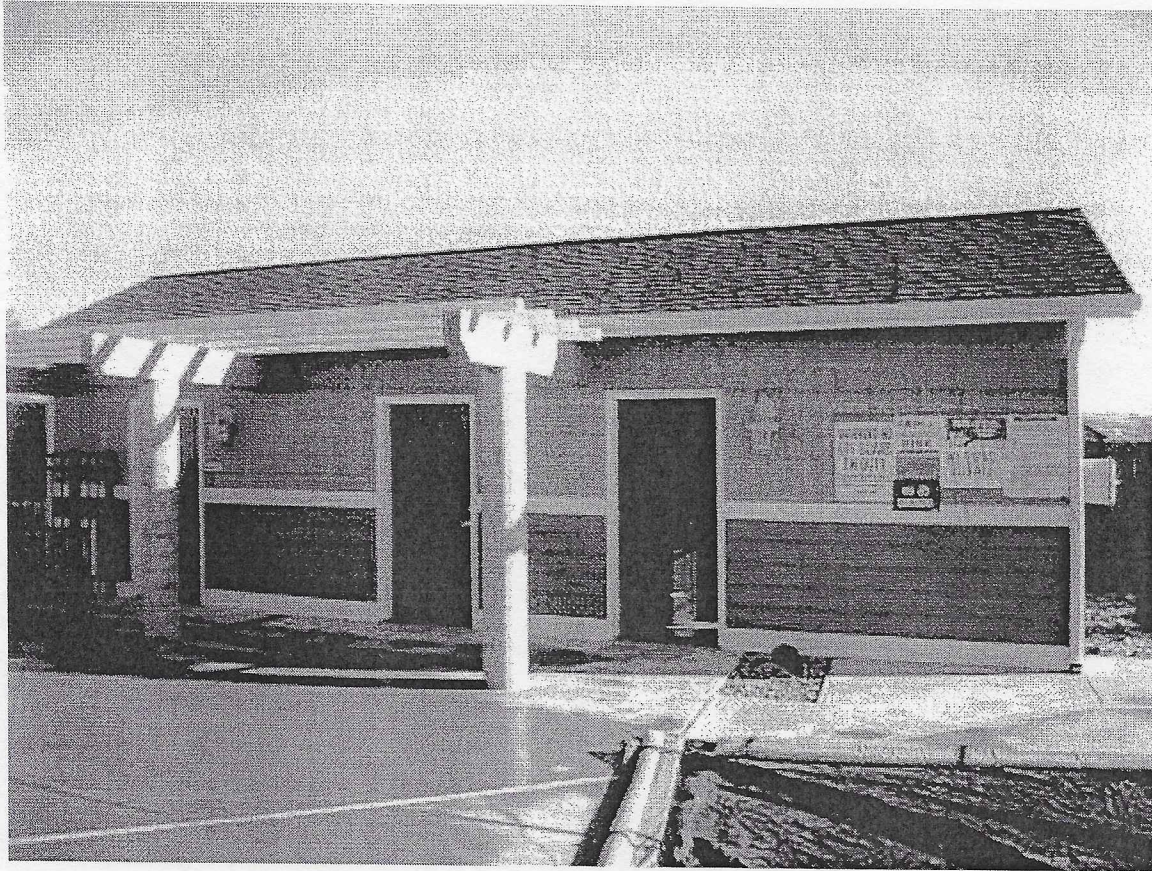
Component: Bathroom/Pumphouse Roof – Replace

Comments: Fair condition with no damage, unevenness or missing shingles observed during our limited scope visual inspection. No reported problems at this time. We assume the roof to have been correctly installed per the manufacturers specifications. We suggest regular professional inspections and prompt repairs as needed to ensure waterproof integrity. Keep gutters and downspouts clear and free of debris. Plan for replacement at roughly the time frame below.

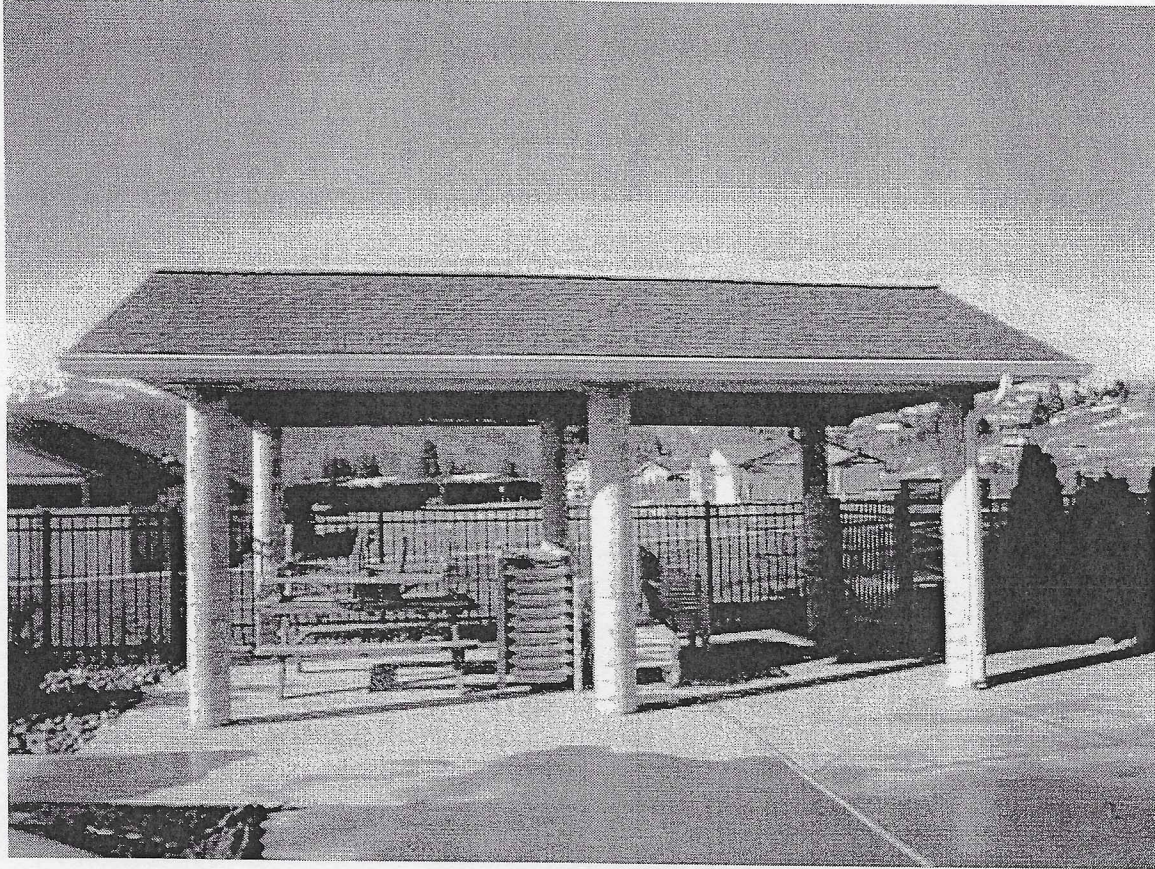
Component: Covered Patio Roofs – Replace

Comments: Fair condition with no damage, unevenness or missing shingles observed during our limited scope visual inspection. No reported problems at this time. We assume the roof to have been correctly installed per the manufacturers specifications. We suggest regular professional inspections and prompt repairs as needed to ensure waterproof integrity. Keep gutters and downspouts clear and free of debris. Plan for replacement at roughly the time frame below.

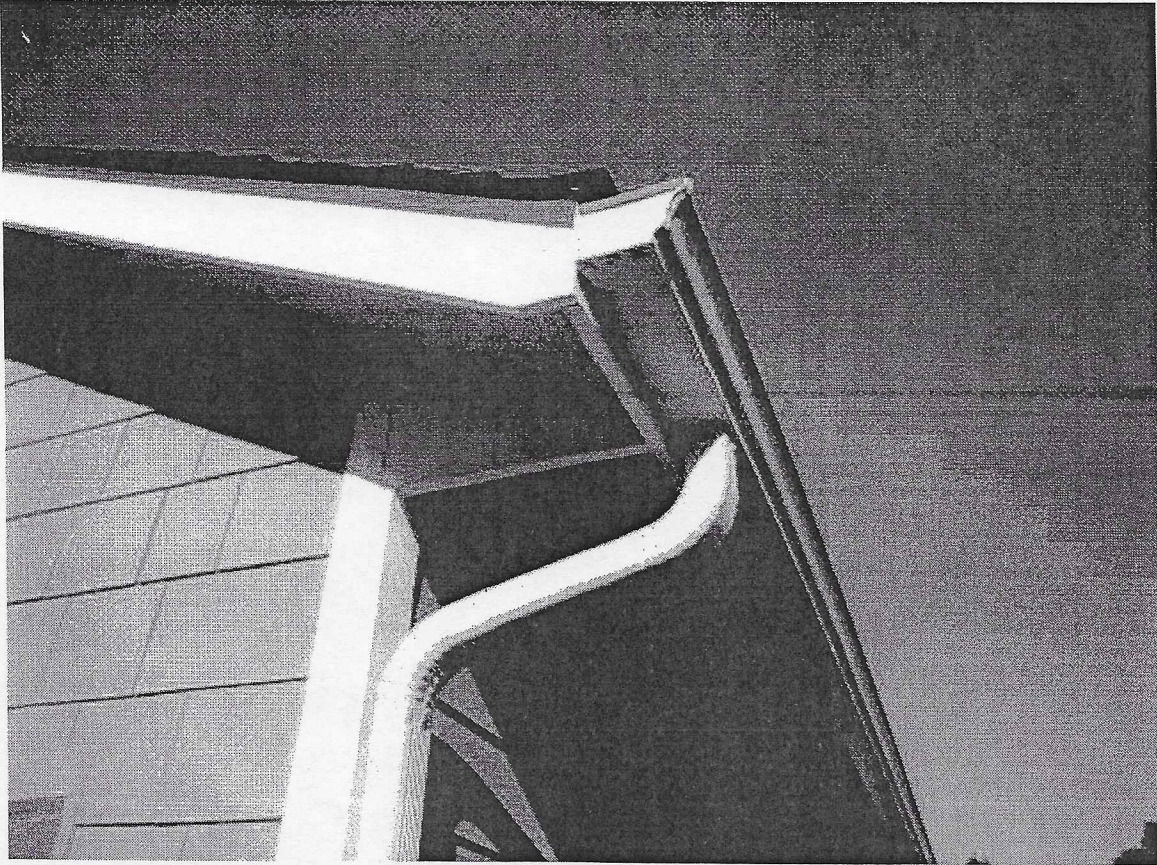
Component: Gutters/Downspouts – Repair/Replace

Comments: Fair condition with no damage observed. Inspect regularly and keep gutters and downspouts free of debris. Repair as needed from general maintenance funds. No anticipation of total replacement within the scope of this report. Repair/replace isolated areas as needed from general maintenance funds.
