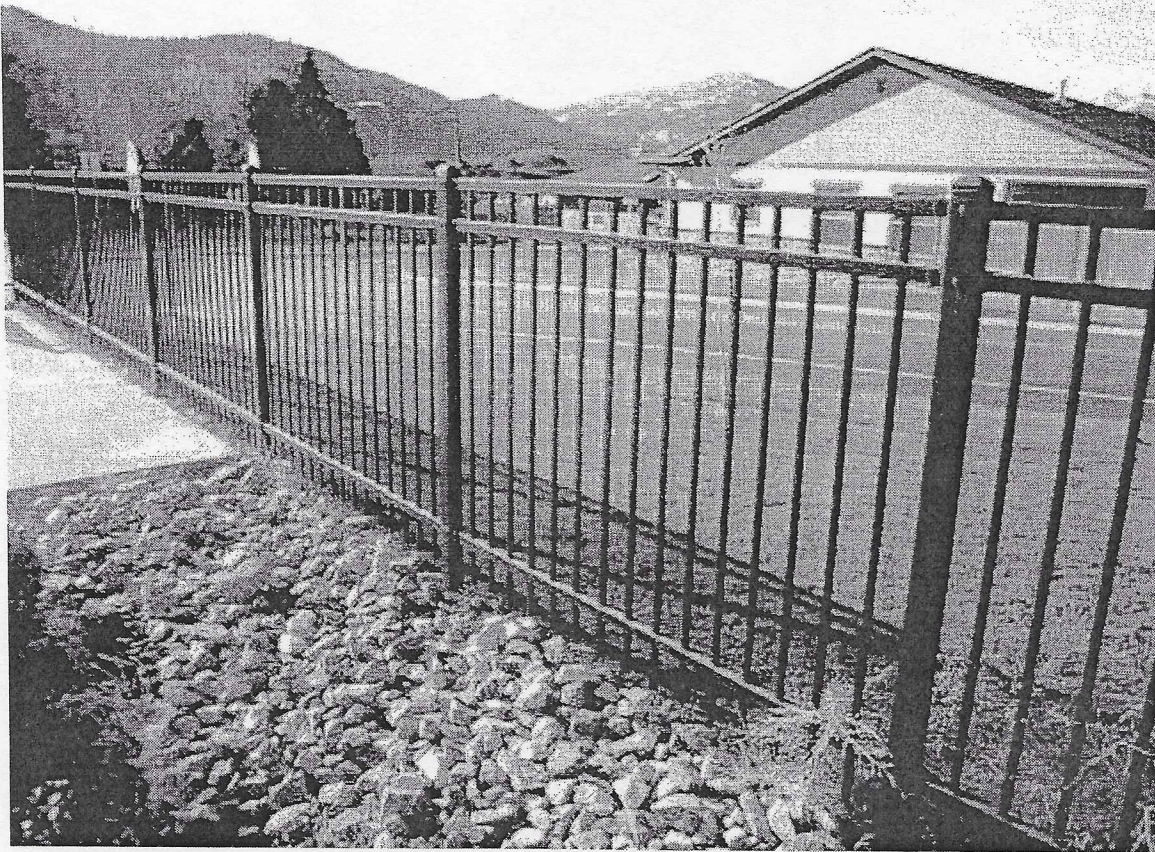
Component: Iron Fence – Replace

Comments: Fair condition observed during our inspection with no significant deterioration or instability apparent. This metal rail can last for an extended period of time if not damaged or abused. Inspect regularly to ensure safety. Repair as needed from operating budget. We do not expect large-scale or total replacement within the scope of this study. No reserve funding suggested.

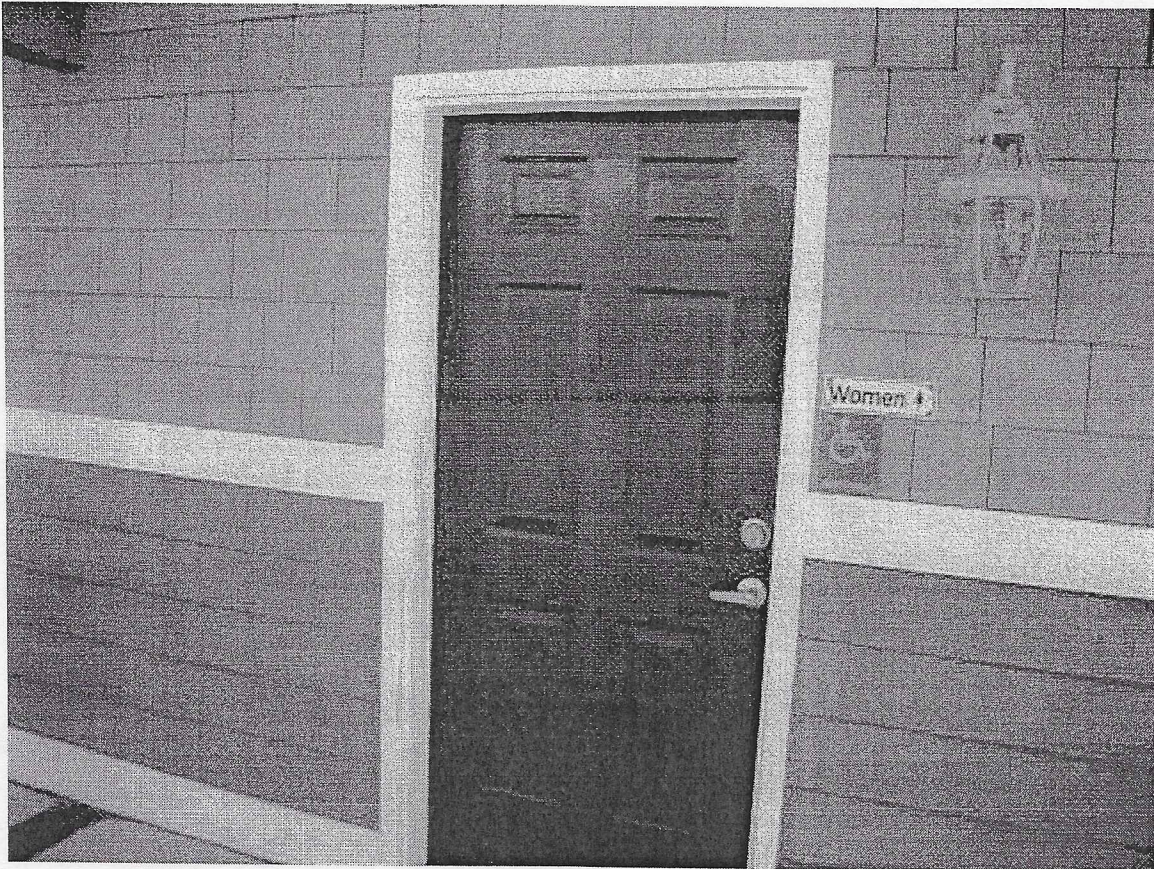
Component: Doors – Replace

Comments: Fair condition of doors observed during our inspection. Repair as needed from general maintenance budget. Clean and paint along with other building surfaces. No reserve funding required.
